## **Stated Destruction of Austro-Hungarian Fortification around the City of Sarajevo with a Focus on the Objects „Polygon“, „Pašin brdo“ und „Vra[t]ca“.**

The aim of this report is to give an overview about the very negative development regarding the state of preservation of Austro-Hungarian fortification around the city of Sarajevo. The site inspection of the forts Polygon, Pasin brdo and Vratca on the 11th respectively 12th of October this year and the discover of evident loss of substance lead the author to write this report. The survey of fort Vraca was done during an excursion that was part of the symposium „Civil-military Cooperation regarding Cultural Property Protection in Crisis Response and its aftermath“.

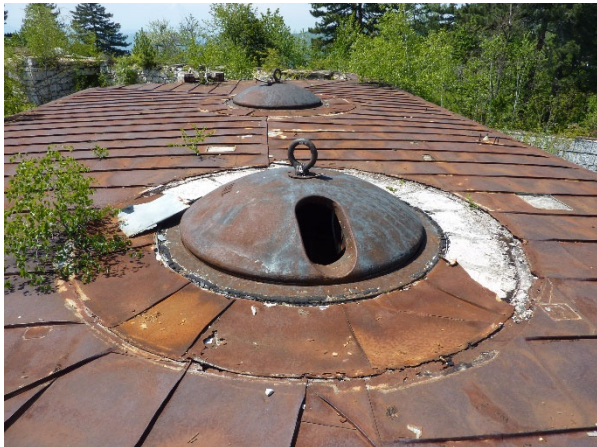
Fig. 1: Tin roof on the battery block, May 2011

1. Most visible is the removal of the sheet metal covering. This was almost complete above the central part (battery block) of the accommodation building (see Fig. 1) and

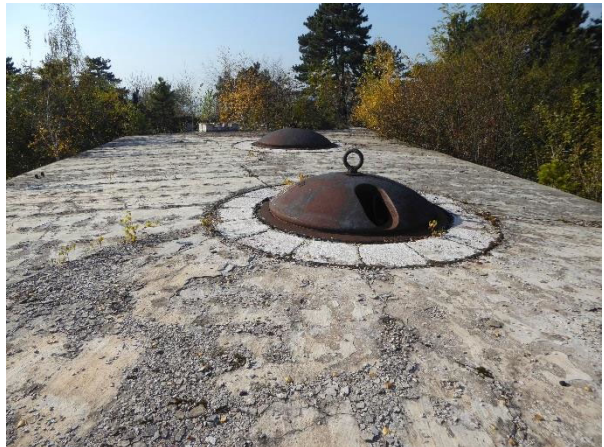
Fig. 2: Completely removed in October 2018

partially preserved in the area of the two flanking elements. As can be seen in Fig. 2, the tin roof is now completely missing. In addition to the historical value - this tin roof was one of the last surviving all over Bosnia and Herzegovina - the lack of water-bearing layer leads to an accelerated deterioration of the fort.

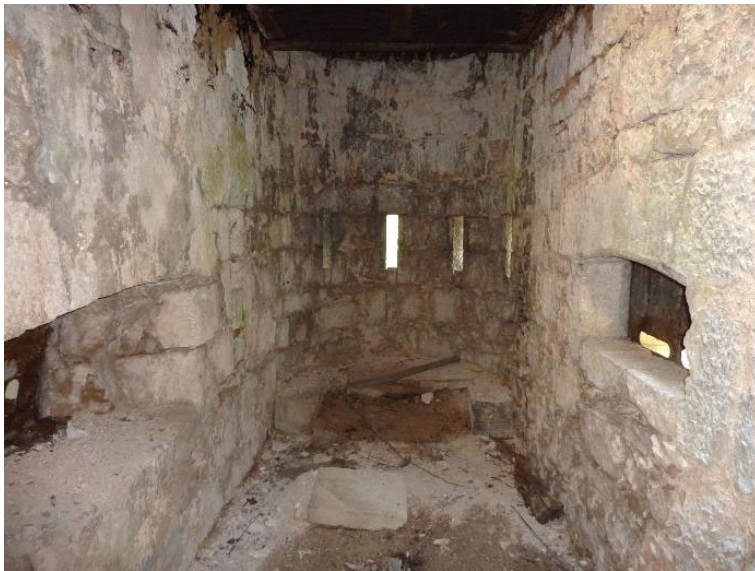
Fig. 3: Inside right caponier, May 2011

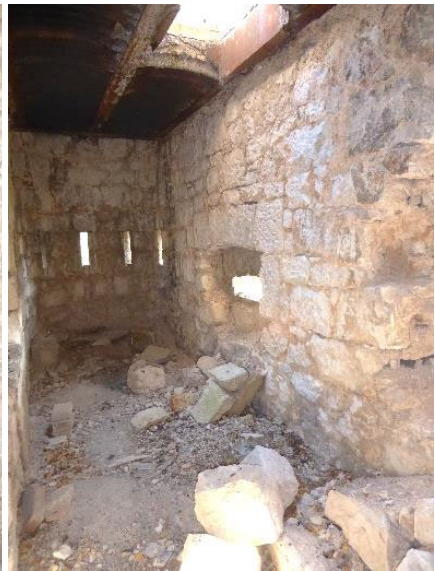
Fig. 4: The same in October 2018: Destruction on masonry and missing armor plates

2. Destruction of the masonry to obtain the high-quality steel armor. In the area of the right flank of the accommodation building (access corridor) and the right caponier, stones were broken out of the masonry (see Fig. 4), in order to subsequently win the steel plates. These were quite well preserved during the documentation in 2011 (see Fig. 3). In addition to the loss of these essential armor, these "artificially induced" damages to the masonry also force further decay. Conversely, subsequent consolidations of such damage are associated with high effort and costs.

All vegetation within the perimeter walls should be removed immediately. Locking the object, which is only accessible through a gate, would at least make further destruction more difficult.

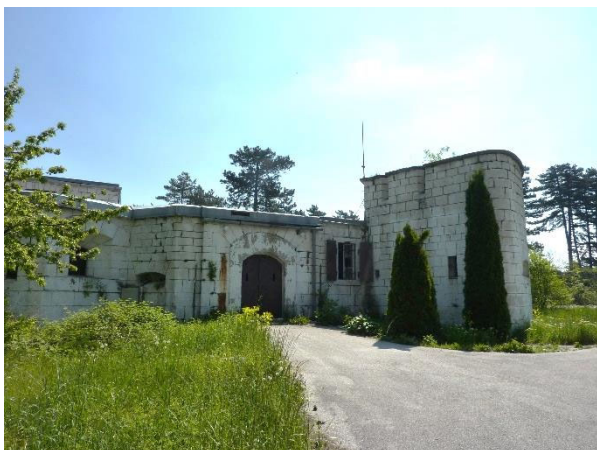
Fig. 5: Entrance of the fort and gorge caponier, May 2011

Comparable to Pašin brdo fort, Polygon also looks abandoned. The object is more overgrown compared to the first ascent in 2011 (see Figures 5 and 6). Since Polygon is still in military possession, the loss of substance here is not so evident, in comparison to Vraca and Pašin brdo. However, the loss of the two bullet-proof steel shutters (see Fig. 7 and 8) close to the main entrance is particularly painful. These elements were, to the knowledge of the author, the last around Sarajevo and probably the last surviving examples of this kind in Bosnia and Herzegovina!

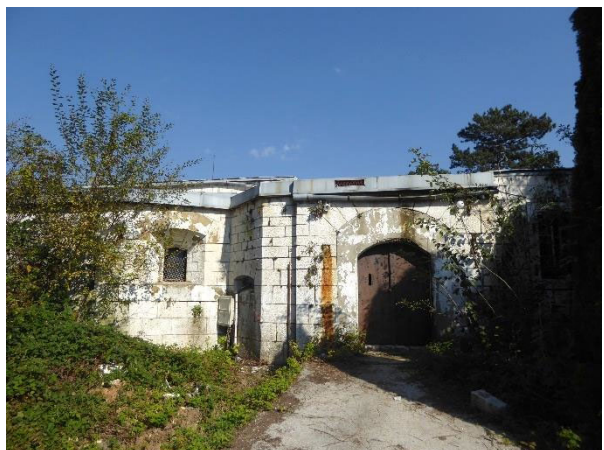
Fig. 6: Growing vegetation, October 2018

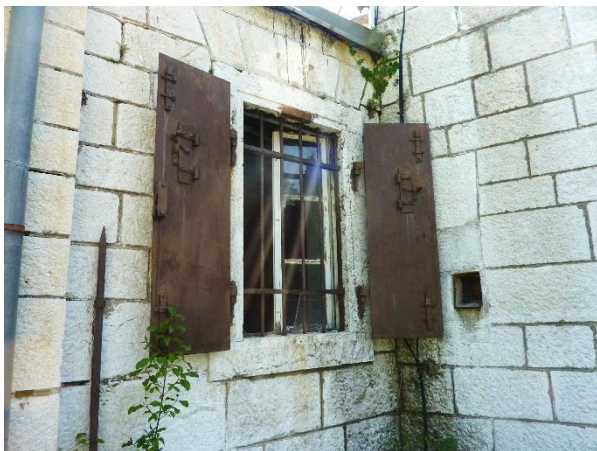
Fig. 7: A window with preserved steel shutters, May 2011

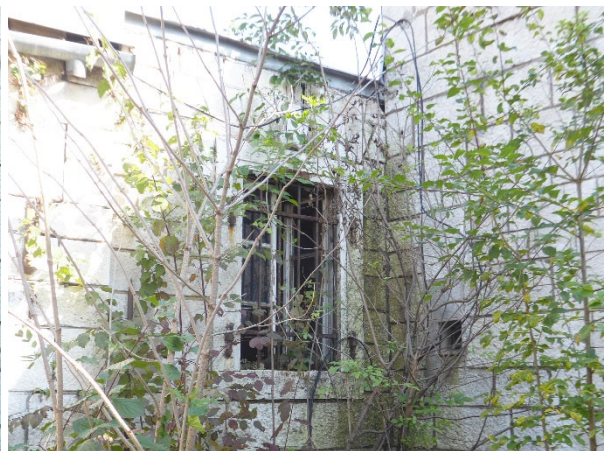
Fig. 8: The same window in October 2018

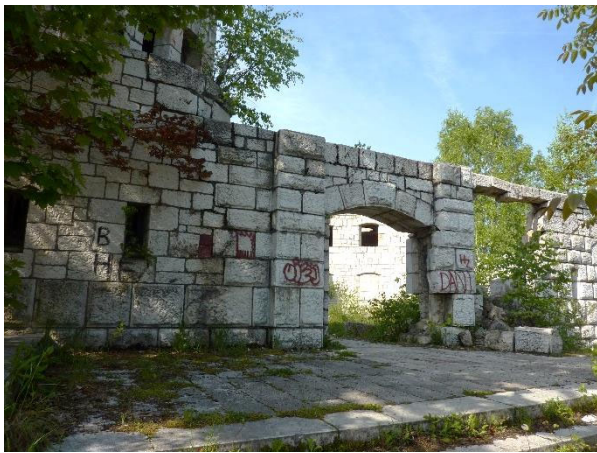
Fig. 9: The main entrance gate, May 2011 Fig. 10: The reconstructed wall and the new steel gate, October 2018

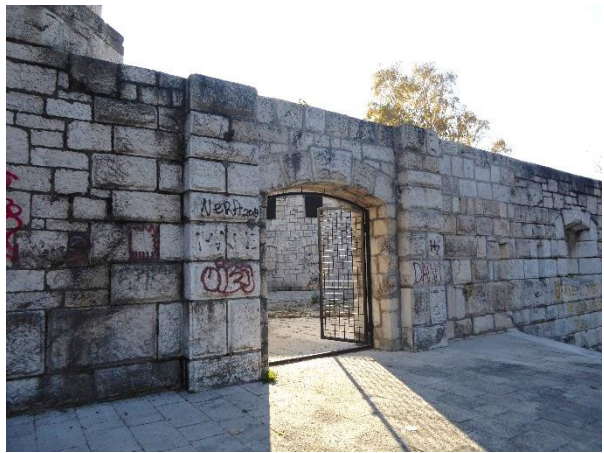
It should be noted that obviously the public authorities have responded to the theft of observation domes, steel sliding shutters, etc., and the fort is closed for the public now. That is, Vratca fort can only be entered by occasion of a guided tour. In this context, the gorge wall (main entrance) was reconstructed. These safeguards are to be seen as a positive development. In terms of international conventions on monument preservation, however, the reconstructed sections (see Fig. 10, right in the picture) should differ both from the original masonry and from the reconstructed of to the 1980s (also recognizable to the laity).

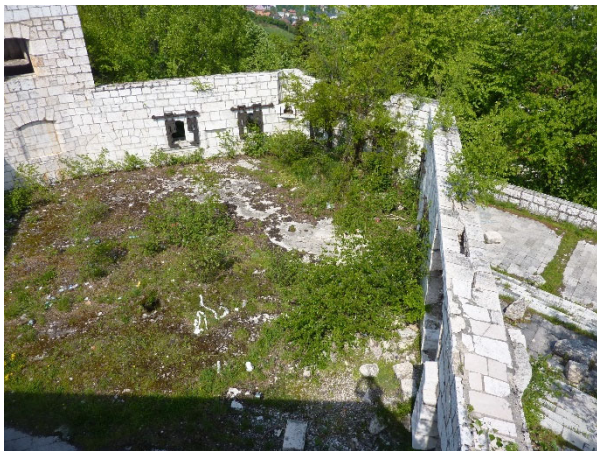
Fig. 11: Courtyard with gorge battery, May 2011

Noteworthy in this object were the numerous, until about 2014 received details. In addition to the two armored cupolas for each a 15cm mortar / mark 1880 were the two rotatable observation posts (see Fig. 13), the steel shutters for the gun embrasures both in the front and gorge battery (see Fig. 11) and many original gates on the ground floor of the barracks building and the front-side caponier. The steel shutters and the wooden gates studded with sheet metal (see Fig. 15) were the last in Bosnia and Herzegovina to be preserved. The two stolen observation turrets were among the last four (!) Surviving of the entire Habsburg monarchy, leaving 50% of this type irretrievably lost.

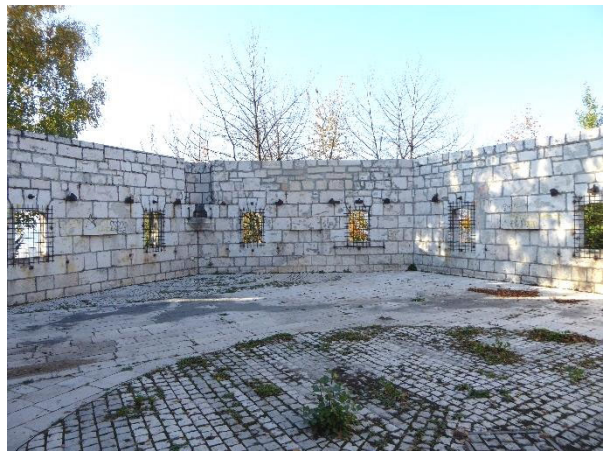
Fig. 12: The same in October 2018

2. The **steel sliding shutters** protecting the gun embrasures represent a significant loss. Fort Vratca was the last object in which these were still present in situ!
3. At least as painful is the theft of the two **rotatable observation turrets**, which were built in 1897 by the company Emil Skoda in Pilsen [Plzeň]. In 2011, a total of five examples were preserved. Since the two turrets of Vratca have been discontinued, only two have survived worldwide.

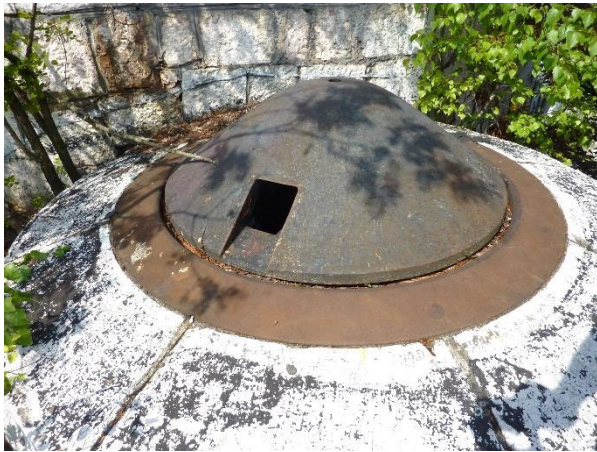
Fig. 13: Rotatable observation post on the left caponier, May 2011

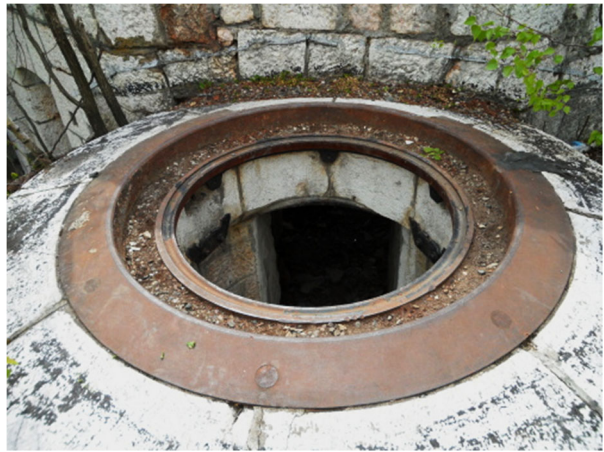
Fig. 14: Cupola is missing since 2014

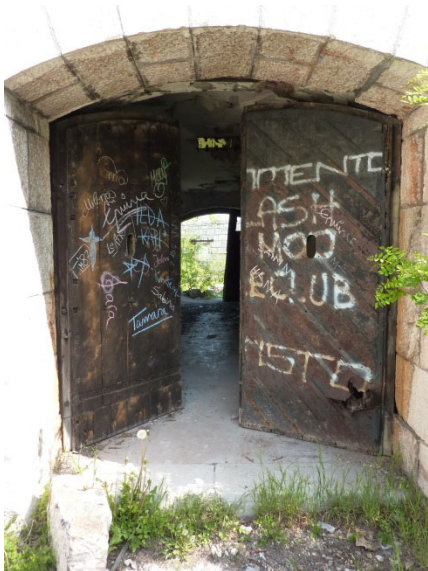
Fig. 15: Entrance to the barracks, May 2011

1. The **two-winged doors** from the construction period of the ground floor of the accommodation building (see Fig. 15) and the door leading to the front side caponier. They were among the last preserved elements of this kind!

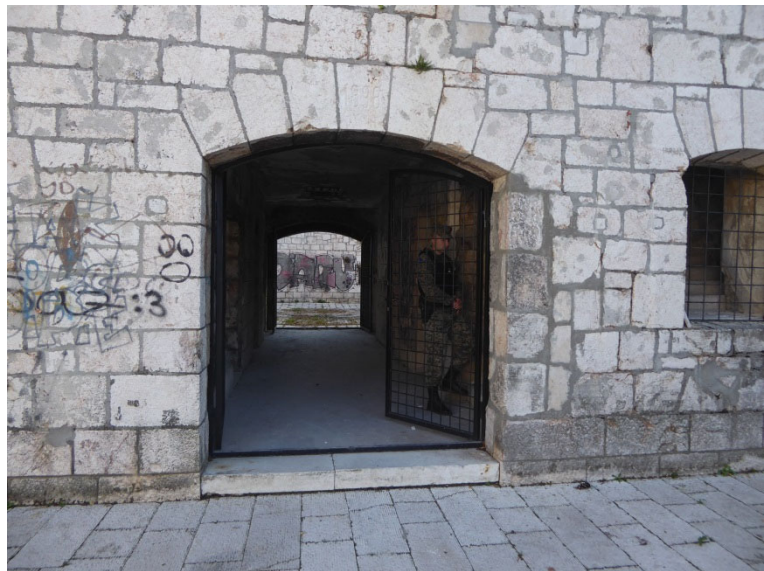
Fig. 16: The same in October 2018
